Client Log - Triangle

Date: 04/05/2018

Dragonfly Maintenance Report	
Property	SOUTHERN VILLAGE
Client Name	Patsy Smith, Michelle Johnson, John Christian
Client Email Address	patsysmith7077@gmail.com
Client Email Address 2	michelle@berkeleychapelhill.com
Client Email Address 3	wego4@mac.com
Client Email Address 4	
Number of Ponds & Pond Type	4 Wet Ponds
Service Type	
Standard	
Mowing Schedule	2 Mowings Per Year
Mowing Service	
Mowing occurs inside of the fence.	
Special Instructions	
None	
Pond Locations	https://imageshack.com...

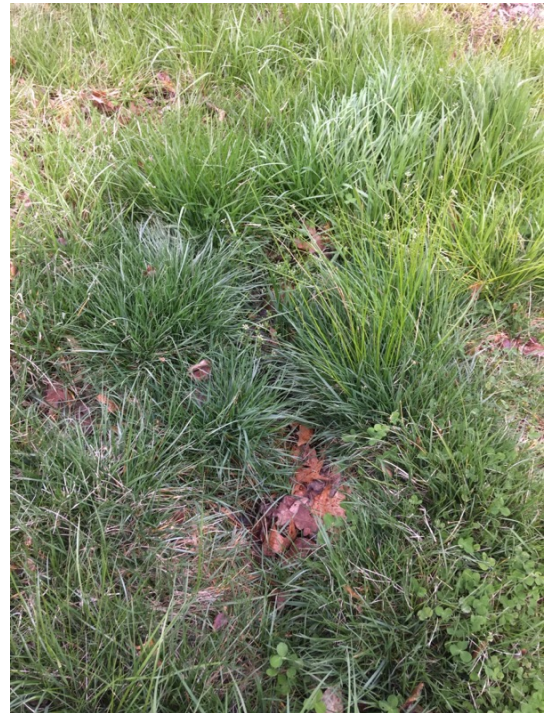
Noted Image 1

Image 1 shows erosion underneath the vegetation.

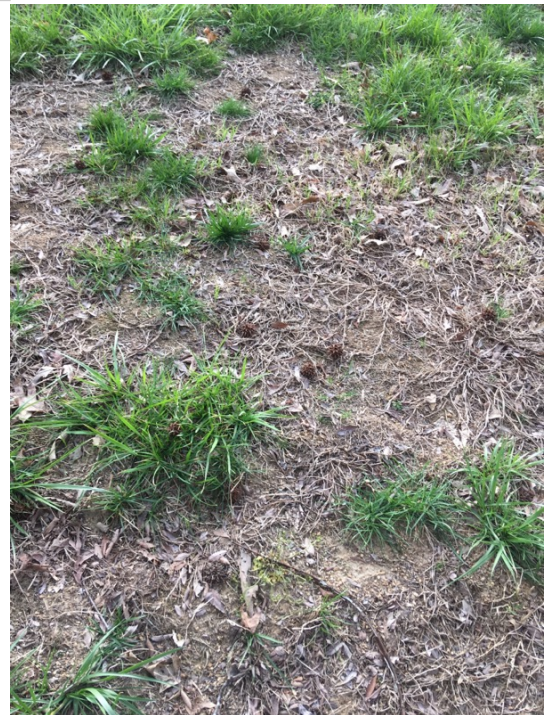
Noted Image 2

Image 2 shows bare soil on the back side of the dam.
