Client Log - Triangle

Date: 01/11/2019

### Dragonfly Maintenance Report

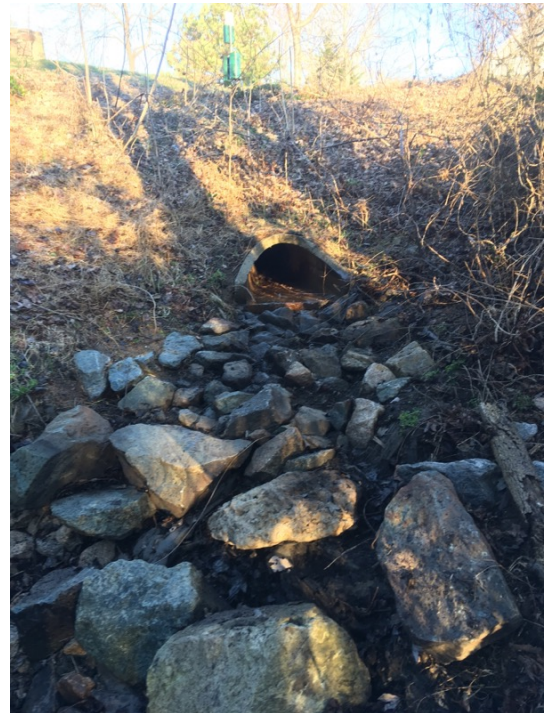
Noted Image 1

Noted image 1 shows secondary outlet.

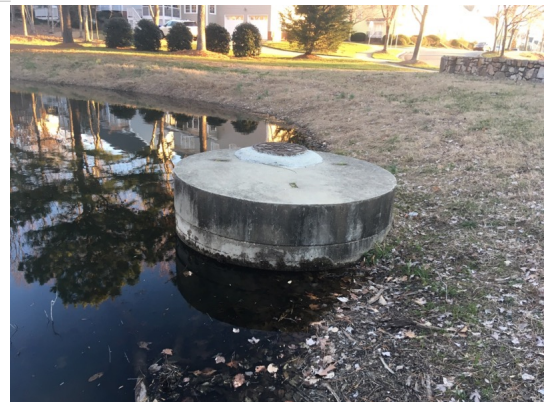
Noted Image 2

Noted image 2 shows secondary riser.

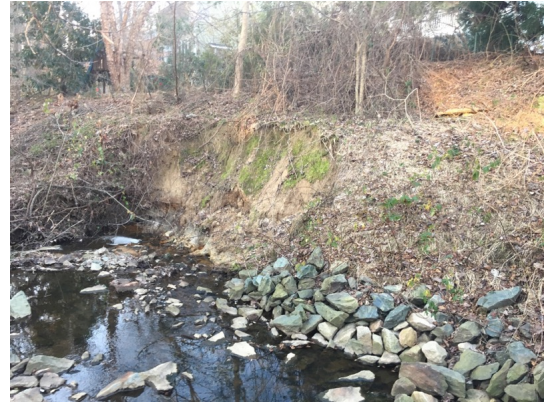
Noted Image 3

Noted image 3 shows erosion at outlet area.

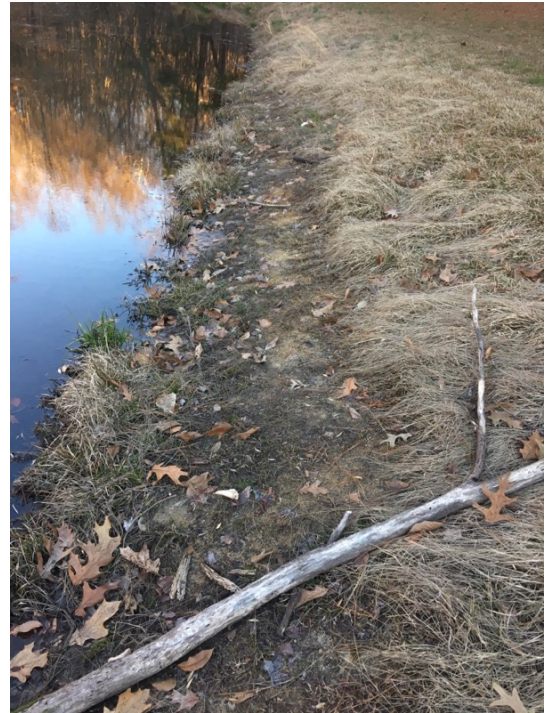
Image 4

Noted image 4 through 6 show exposed soil along shoreline and slope of pond.

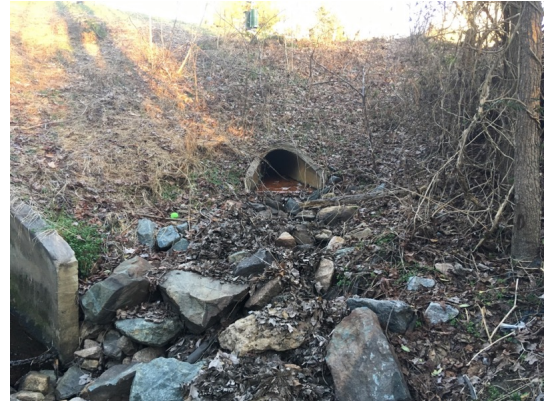
Image 7

Noted image 7 shows secondary outlet before clearing leaves and debris.

Trash removed and outlets cleared of leaves and debris.

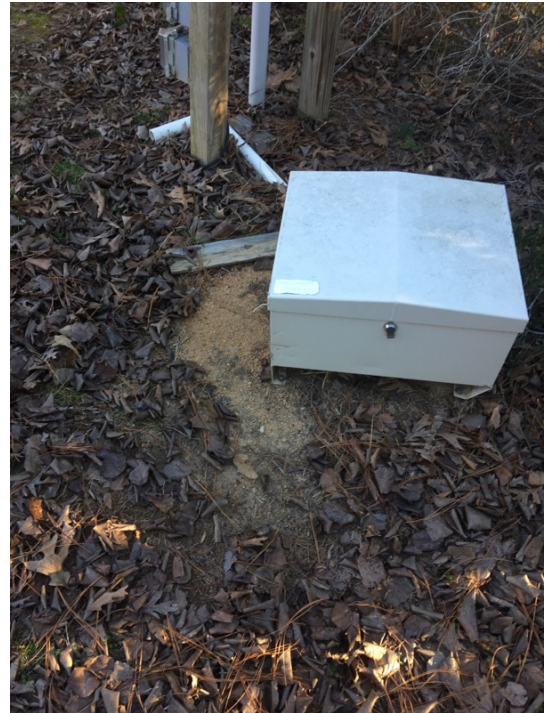
### Noted Image 1

Noted image 1 shows air compressor box with exposed soil. Key required for access.

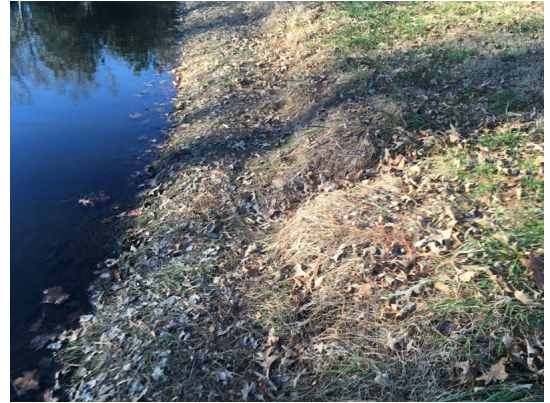
Noted Image 2

Noted image 2 shows erosion along shoreline slope.

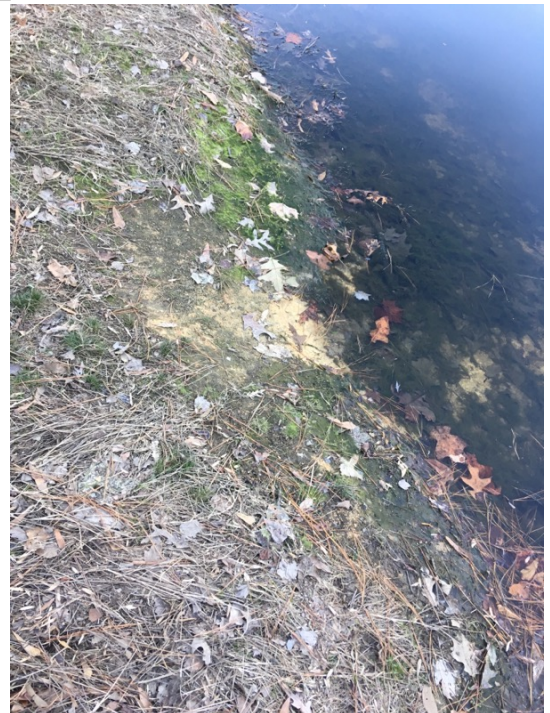
Noted Image 3

Noted image 3 shows bare soil next to riser shoreline.

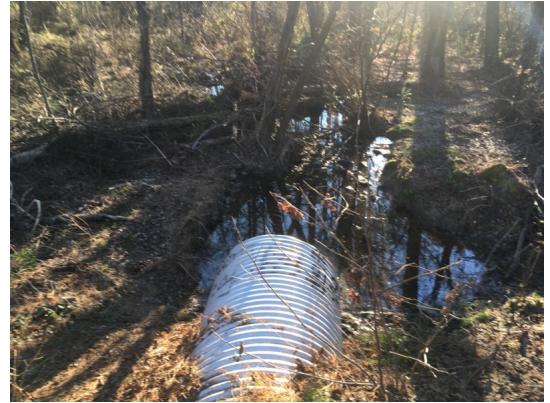
Image 4

Noted image 4 shows overhead view of outlet pipe.

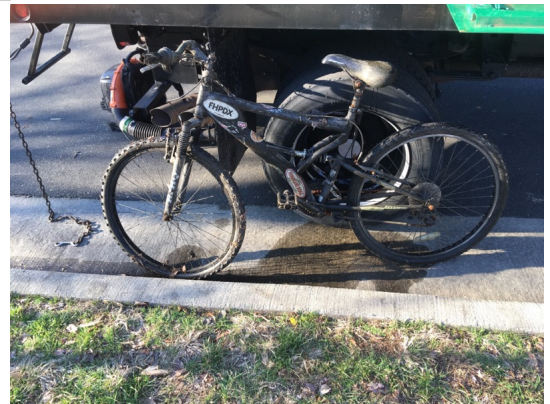
Image 5

Noted image 5 shows bike removed from pond.

Trash removed and drawdown orifice cleared of debris. Bicycle removed from pond.

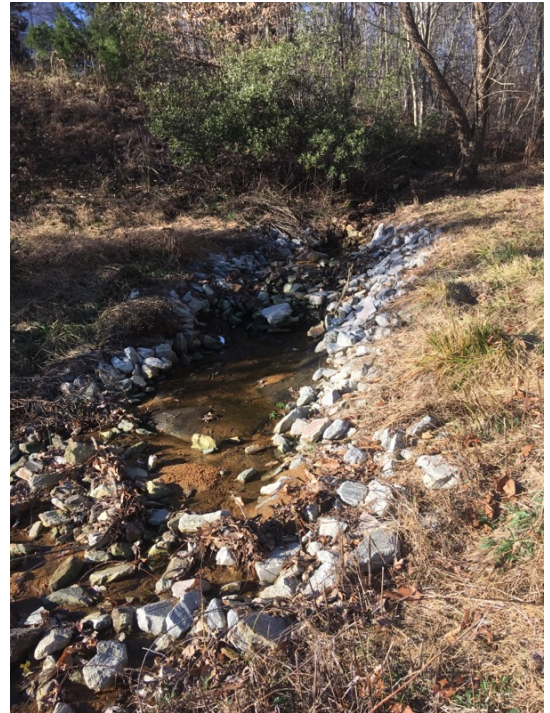
### Noted Image 1

Noted image 1 through 4 show secondary inlets.

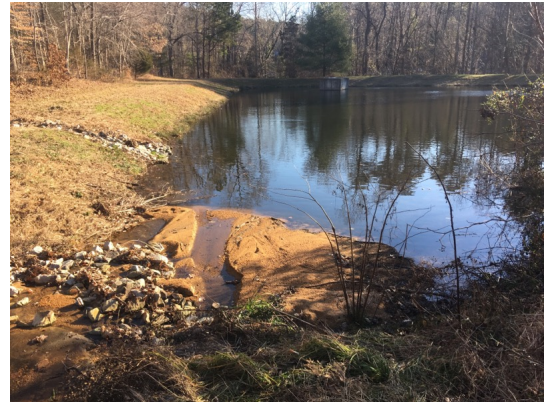
Image 5

Noted image 5 shows sedimentation and silt build up from inlet.

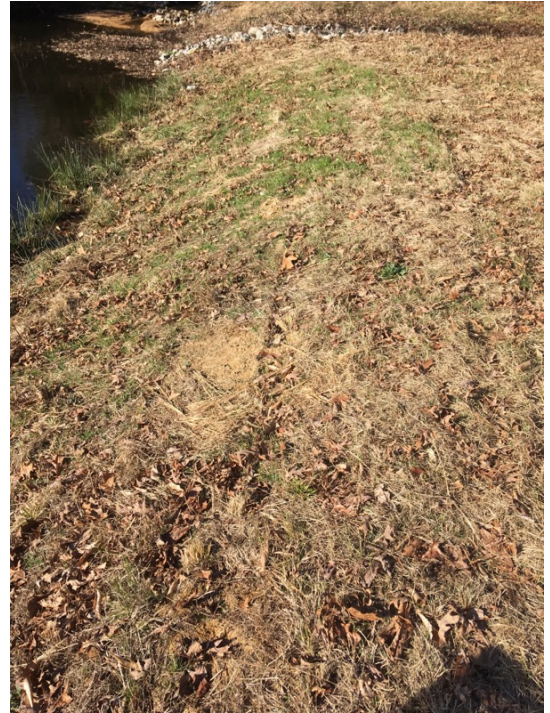
Image 6

Noted image 6 through 8 show exposed soil due to disturbed areas.

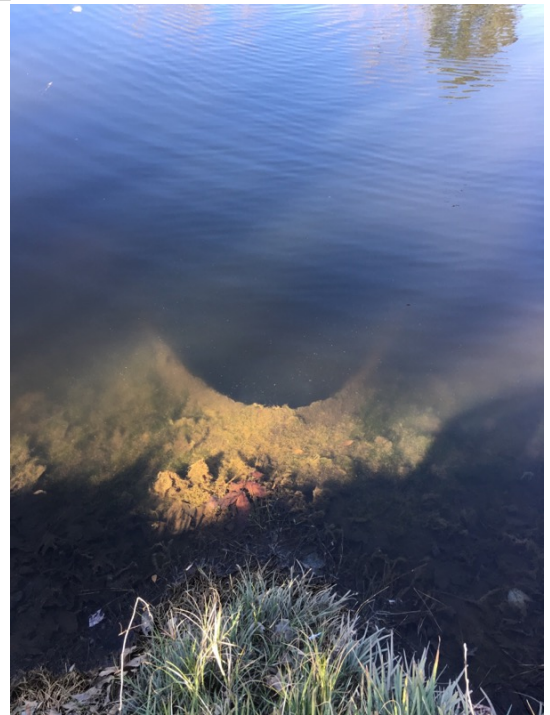
### Noted Image 1

Noted image 1 and 2 show secondary inlets.

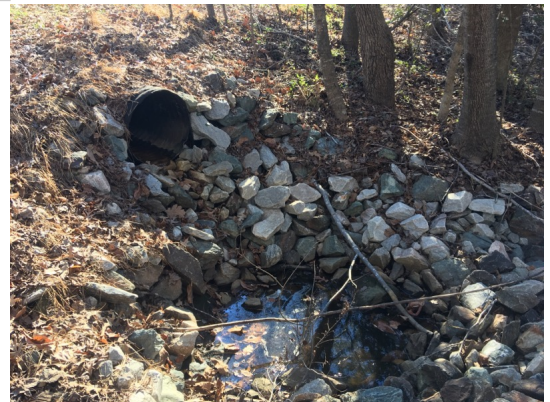
Noted Image 3

Noted image 3 shows outlet before clearing debris.

Trash removed and outlet cleared of debris. Aeration diffuser functioning properly.

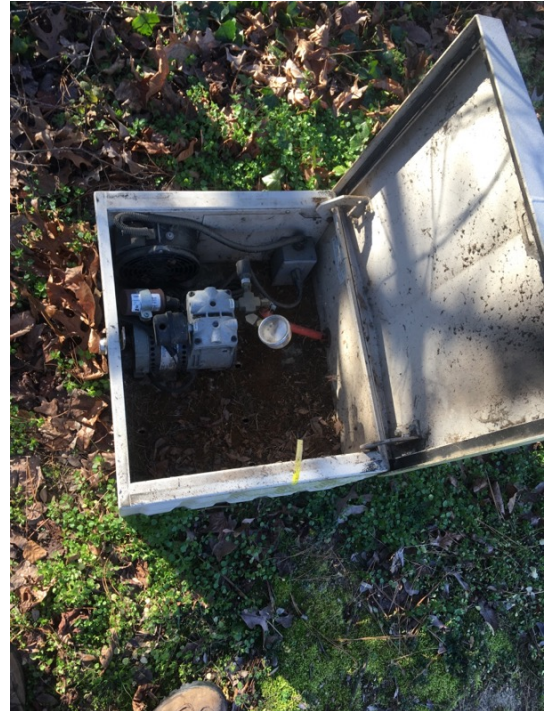
Image 4

Noted image 4 shows compressor for aeration system.

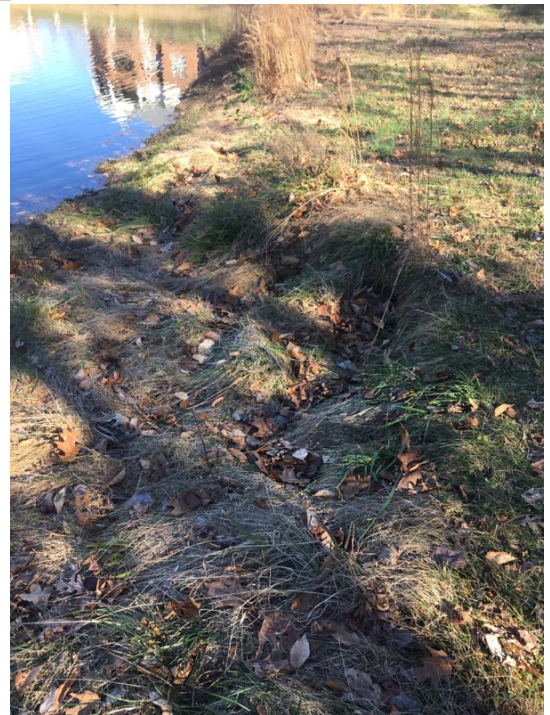
Image 5

Noted image 5 shows erosion at pond shoreline.
