Client Log - Triangle

Date: 02/19/2019

Dragonfly Maintenance Report

Property	SOUTHERN VILLAGE
Client Name	Patsy Smith, Tony Smith
Client Email Address	patsysmith7077@gmail.com
Client Email Address 2	tony@berkeleychapelhill.com
Client Email Address 3	
Client Email Address 4	
Number of Ponds & Pond Type	4 Wet Ponds
Service Type	
Standard	
Mowing Schedule	2 Mowings Per Year
Mowing Service	
Mowing occurs inside of the fence.	
Special Instructions	
Pond 4 #5150	
Pond Locations	https://imageshack.com...

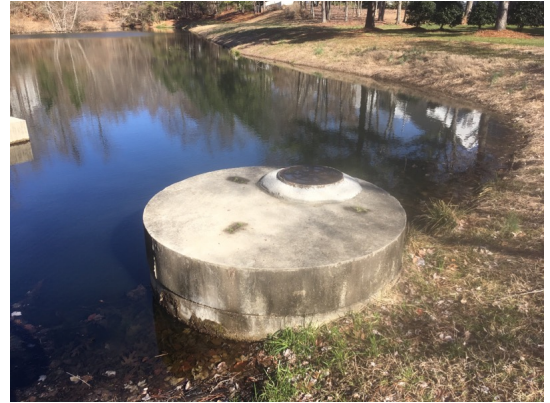
Noted Image 1

- Noted image 1 shows manhole.
 - Noted image 2 shows secondary outlet.
 - Noted image 3 shows erosion and exposed soil along pond shoreline.
 - Noted image 4 shows exposed soil and matting bear pond inlet.
 - Noted image 5 shows exposed tarp at secondary inlet.
- Trash removed.

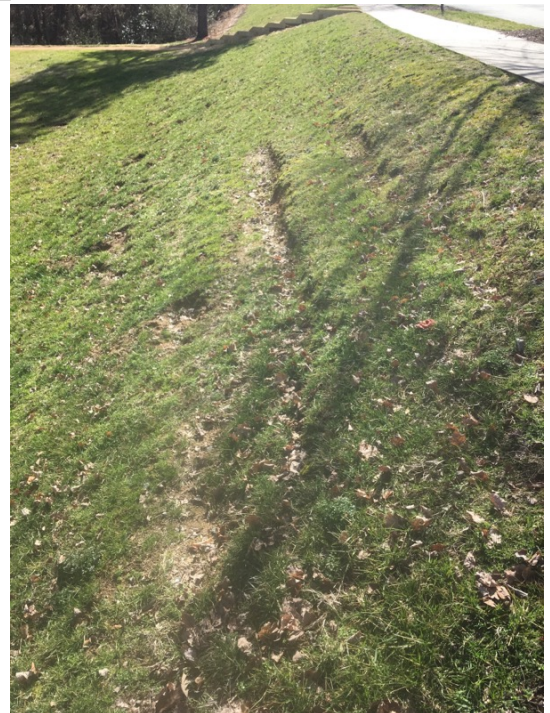
Noted Image 1

Noted image 1 shows disturbed area along slope closest to road.

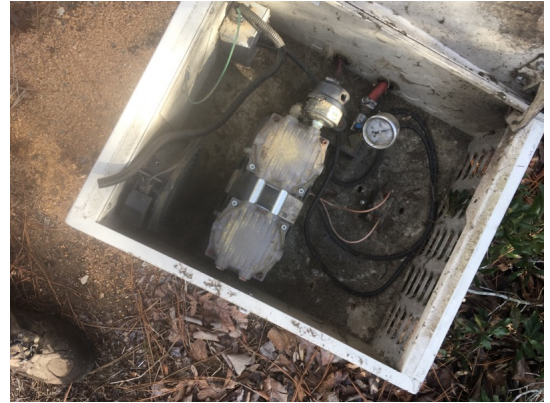
Noted Image 2

Noted image 2 shows compressor running for aeration system. Two diffusers present.

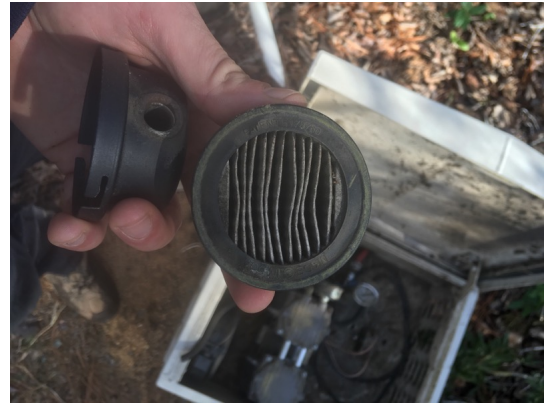
Noted Image 3

Noted image 3 shows an old compressor filter. Recommend replacing.

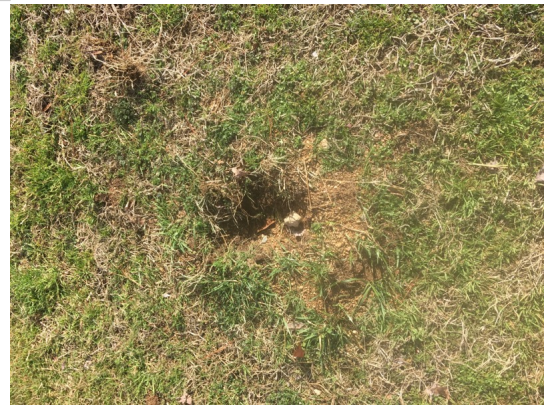
Image 4

Noted image 4 shows one of multiple holes along pond slope closest to road.

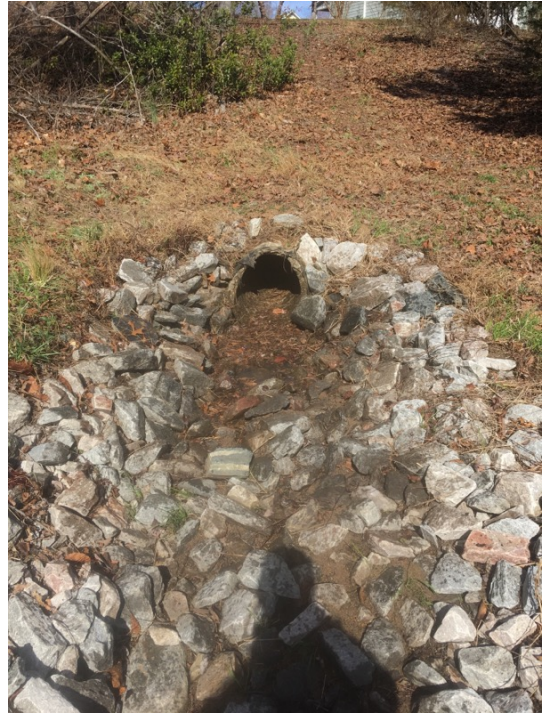
Noted Image 1

Noted image 1 and 2 show secondary inlets. One of the inlets submerged underwater.
Noted image 3 shows disturbed area above submerged inlet.
Noted image 4 shows fallen tree on dam.
Noted image 5 shows additional inlet from primary inlet branching.
Noted image 6 shows sedimentation at the primary inlet.
Noted image 7 shows erosion at the backside of the dam.
Noted image 8 shows exposed soil on top of the dam.
Primary stream inlet washed out. Additional riprap suggested.
Trash removed and leaves blown from inlet riprap.

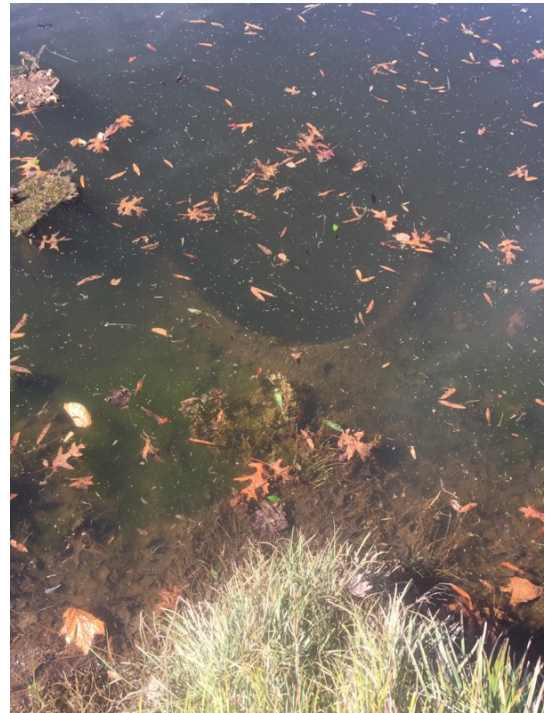
Noted Image 1

Noted image 1 shows secondary inlet.

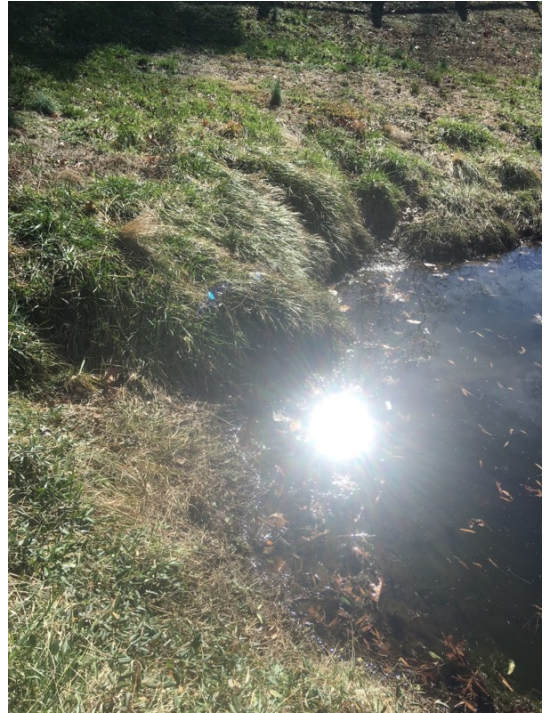
Noted Image 2

Noted image 2 and 3 show erosion.

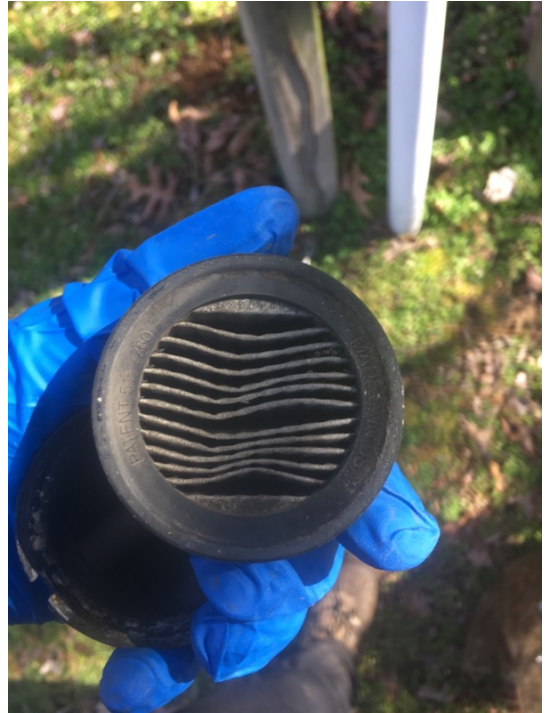
Image 4

Noted image 4 shows aeration system filter. Recommend replacing.

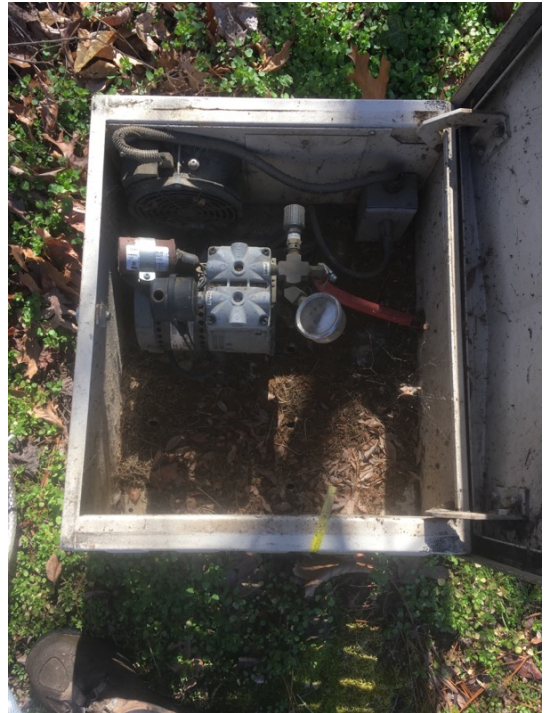
Image 5

Noted image 5 shows the aeration compressor.

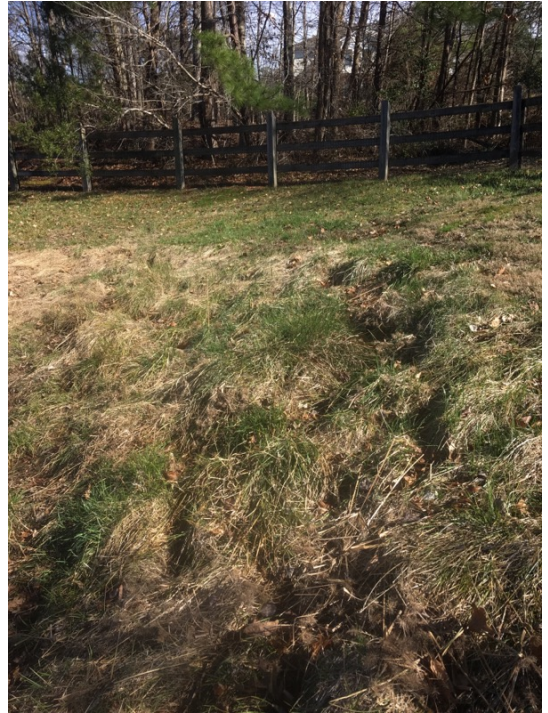
Image 6

Noted image 6 shows erosion.

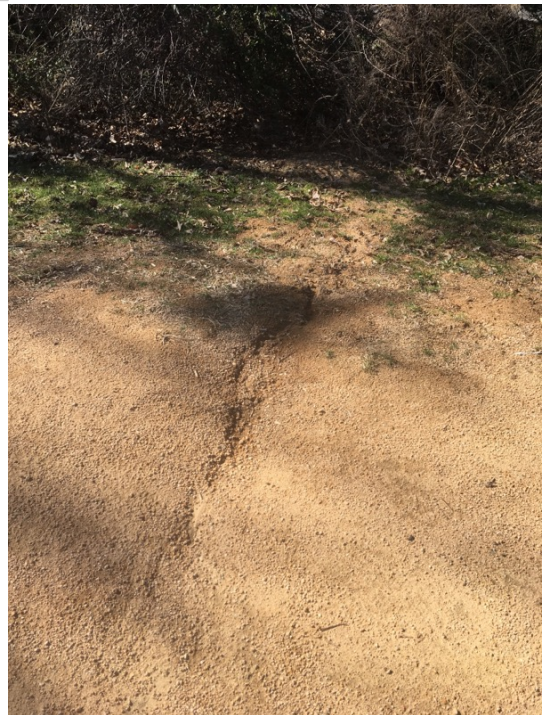
Image 7

Noted image 7 shows channeling at the dam.
