Client Log - Triangle

Date: 03/20/2019

Dragonfly Maintenance Report

Property	SOUTHERN VILLAGE
Client Name	Patsy Smith, Tony Smith
Client Email Address	patsysmith7077@gmail.com
Client Email Address 2	tony@berkeleychapelhill.com
Client Email Address 3	
Client Email Address 4	
Number of Ponds & Pond Type	4 Wet Ponds
Service Type	
Standard	
Mowing Schedule	2 Mowings Per Year
Mowing Service	
Mowing occurs inside of the fence.	
Special Instructions	
Pond 4 #5150	
Pond Locations	https://imageshack.com...

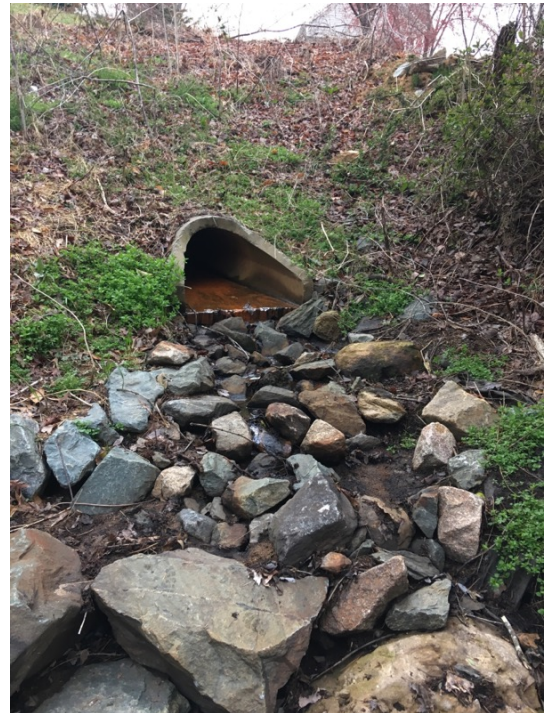
Noted Image 1

Noted image 1 shows a secondary outlet.

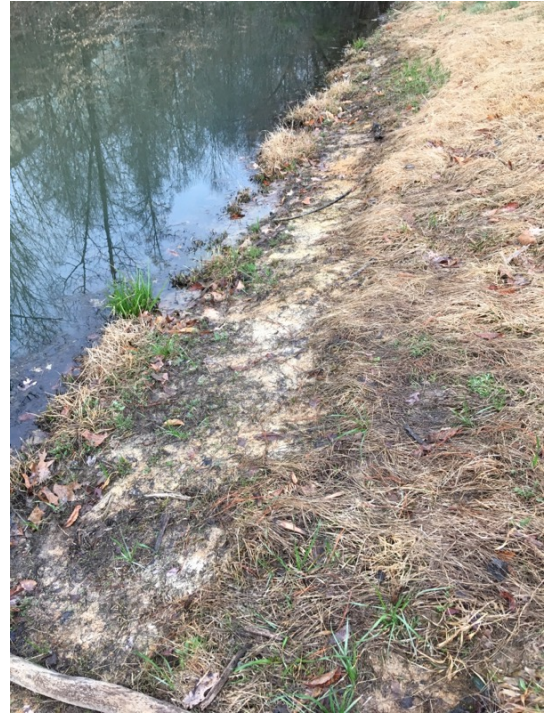
Noted Image 2

Noted image 2 shows exposed soil.

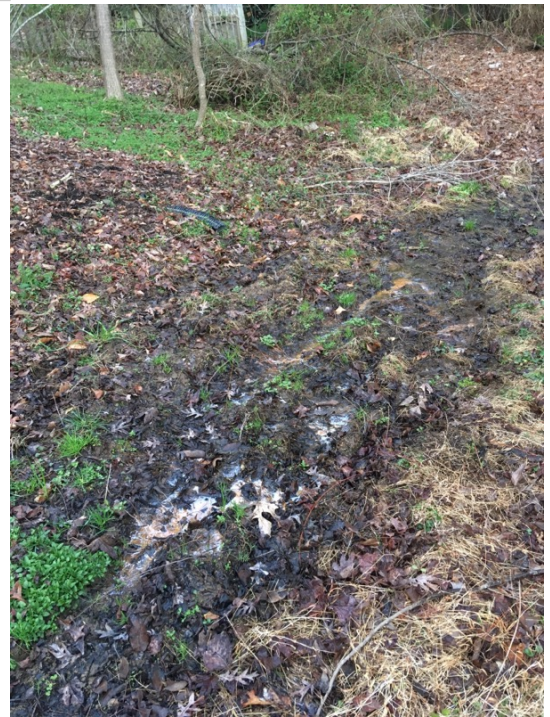
Noted Image 3

Noted image 3 shows a disturbed area and erosion from water running from a residential area.

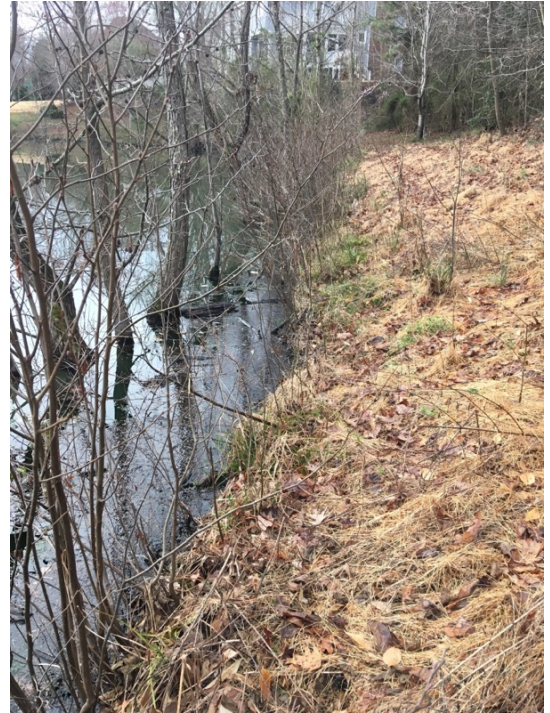
Image 4

Noted image 4 shows large amounts of woody vegetation and recommend mowing and removal.

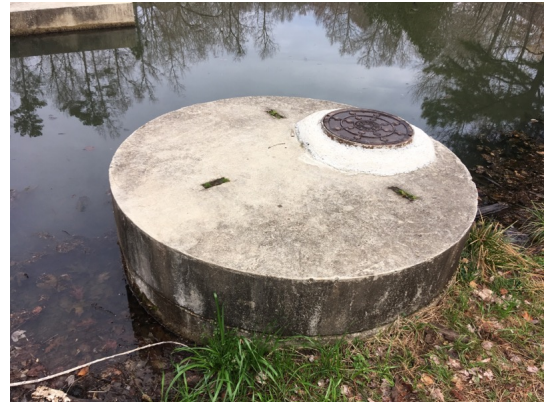
Image 5

Noted image 5 shows a secondary riser.

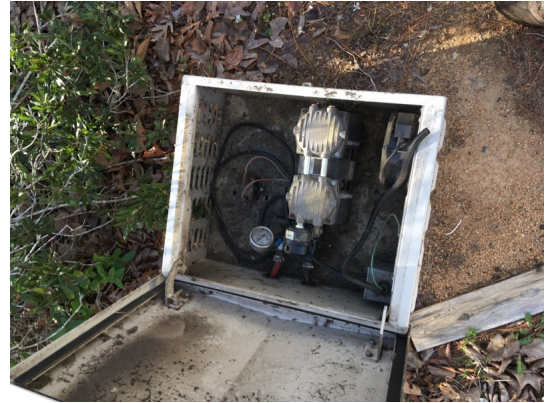
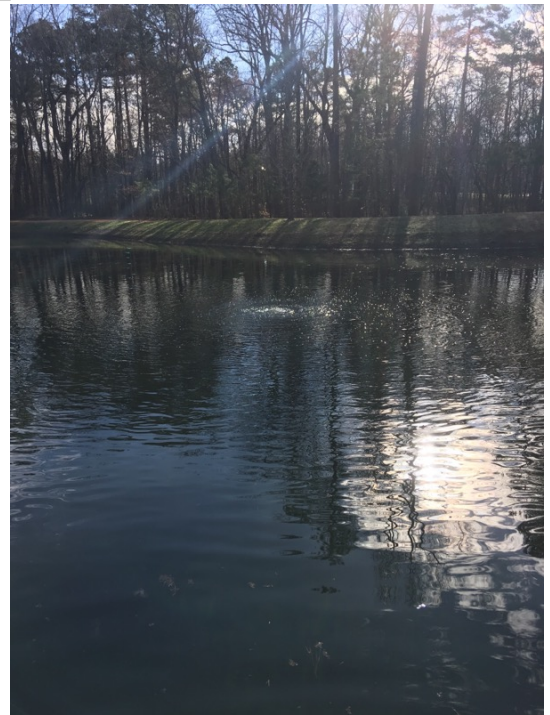
Noted image 1 and 2 show the aeration diffuser and the compressor box. Recommend replacing compressor filter. Two diffusers present.

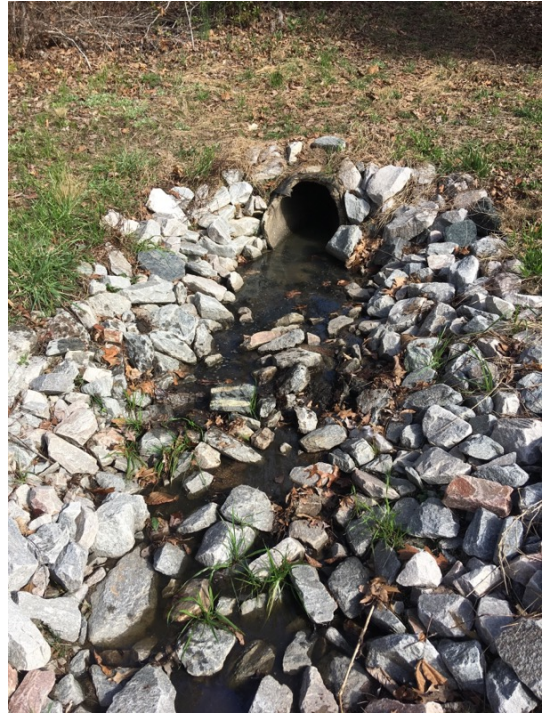
Noted Image 1

- Noted image 1 shows a secondary inlet.
- Noted image 2 shows sedimentation from the creek.
- Noted image 3 shows a new channel forming from the creek.
- Noted image 4 shows exposed soil along the dam.
- Noted image 5 shows a fallen tree.
- Noted image 6 shows a disturbed area.
- Trash removed and pond treated for algae and aquatic weeds.

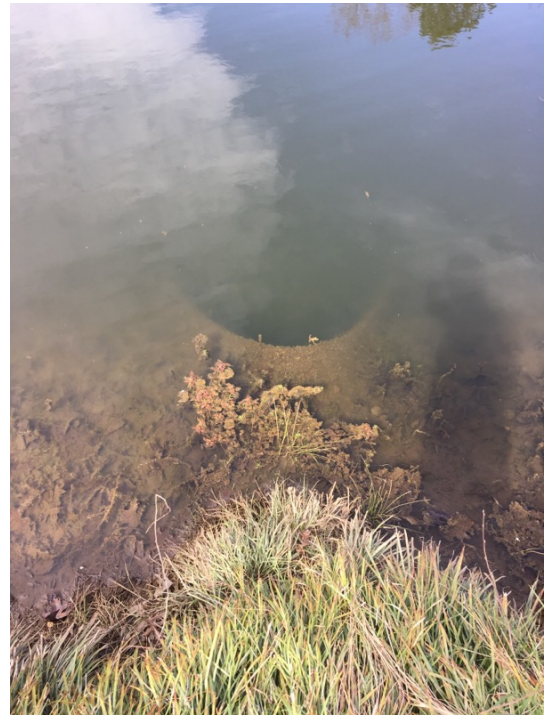
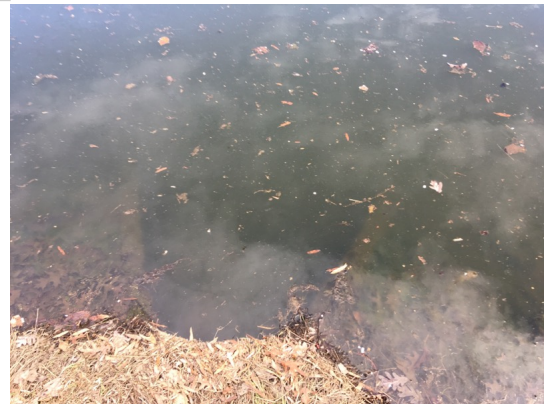
Noted image 1 and 2 show secondary inlets.
Noted image 3 shows erosion.
Noted image 4 shows exposed soil.
Noted image 5 shows the aeration compressor. One diffuser present.
Recommend replacing the compressor filter.
Trash removed and the pond was treated for algae and aquatic weeds.
