Client Log - Triangle

Date: 04/22/2019

Dragonfly Maintenance Report

Property	SOUTHERN VILLAGE
Client Name	Patsy Smith, Tony Smith
Client Email Address	patsysmith7077@gmail.com
Client Email Address 2	tony@berkeleychapelhill.com
Client Email Address 3	
Client Email Address 4	
Number of Ponds & Pond Type	4 Wet Ponds
Service Type	
Standard	
Mowing Schedule	2 Mowings Per Year
Mowing Service	
Mowing occurs inside of the fence.	
Special Instructions	
Pond 4 #5150	
Pond Locations	https://imageshack.com...

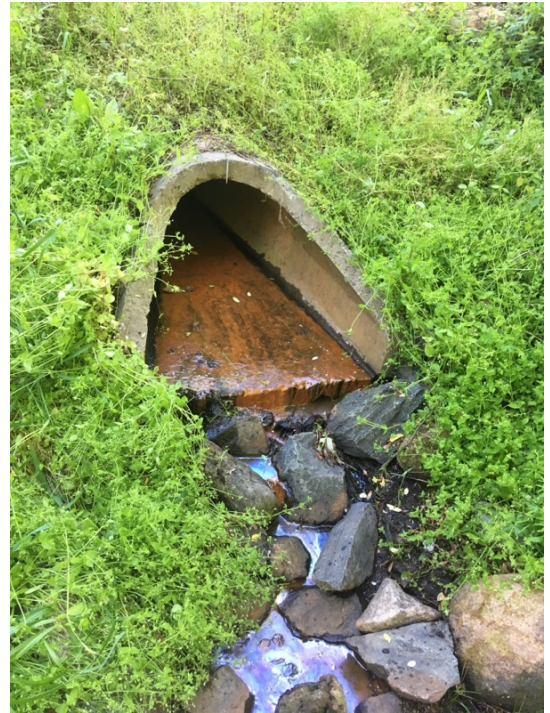
Removed trash from the pond. Added Beneficial bacteria to the pond in order to help promote a healthy ecosystem. Hand pulled terrestrial vegetation growing up at both outlets to ensure that water flow was not impeded. Noted image 1 shows a secondary outlet. Noted image 2 shows erosion along one side of the primary outlet. Noted image 3 shows exposed soil along the pond slope. Noted image 4 shows exposed soil just before the creek inlet. Noted image 5 shows an area of erosion at the creek inlet. Noted image 6 shows an area of the shoreline that is holding water. Noted Image 1

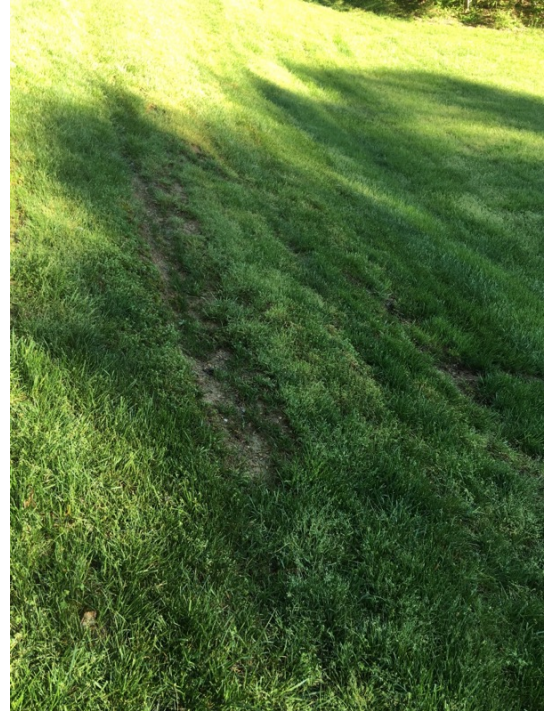
Noted Image 1

Trash removed from the pond. Added beneficial bacteria in order to help promote a healthy ecosystem. Hand pulled nuisance woody vegetation along the shoreline and around the outlet. Observed a large amount of pollen on the surface of the pond. Cleaned the aeration filter. Noted image 1 shows a disturbed area along the pond slope closest to the road. Noted images 2, 3 and 4 show areas of bare soil and erosion on the shoreline of the pond. Noted image 5 shows the aeration box. Aeration system was running normally.

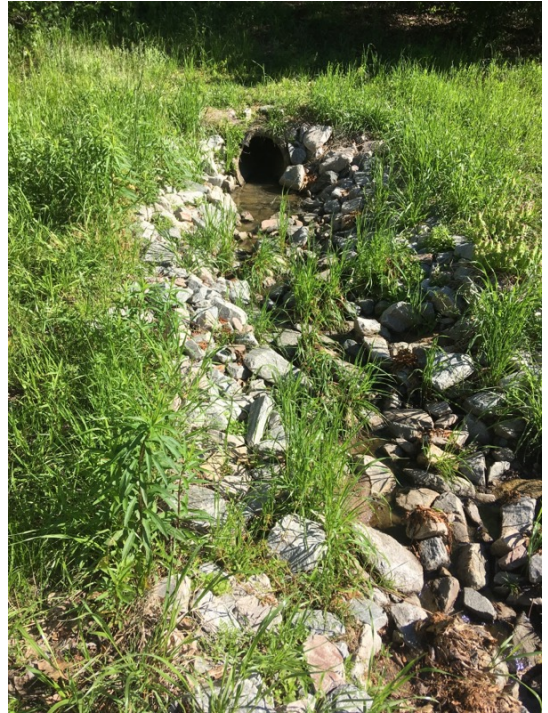
Noted Image 1

Trash was removed from the pond. Treated terrestrial vegetation growing up in the rip-rap around the inlets. Added beneficial bacteria to the pond in order to help promote a healthy ecosystem. Noted image 1 shows a secondary inlet. Noted image 2 shows the creek inlet with sedimentation, exposed matting, and displaced rip-rap. Noted image 3 shows an area of bare soil and erosion in the head section of the pond. Noted image 4 shows a fallen tree on the backside of the dam near the outlet.
