Client Log - Triangle

Date: 04/22/2019

Dragonfly Maintenance Report

Property	SOUTHERN VILLAGE
Client Name	Patsy Smith, Tony Smith
Client Email Address	patsysmith7077@gmail.com
Client Email Address 2	tony@berkeleychapelhill.com
Client Email Address 3	
Client Email Address 4	
Number of Ponds & Pond Type	4 Wet Ponds
Service Type	
Standard	
Mowing Schedule	2 Mowings Per Year
Mowing Service	
Mowing occurs inside of the fence.	
Special Instructions	
Pond 4 #5150	
Pond Locations	https://imageshack.com...

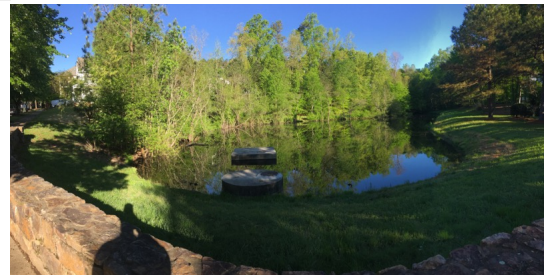
Pond Name	WP 1
Access Address	400 Market St, Chaple Hill, NC
Service Date	04/22/2019
Trash Pickup	SC= Service Completed
Treat Invasives	NN= Service Not Needed
Inlet service	NN= Service Not Needed
Outlet Service	NN= Service Not Needed
Unclog Drain	NN= Service Not Needed
Clean Riser/Trash rack	NN= Service Not Needed
Add Dye?	NN= Service Not Needed
Fountain/Aerator Condition	NN= Service Not Needed
Mow/Weed eat	WN= Work Needed
Overview of the pond

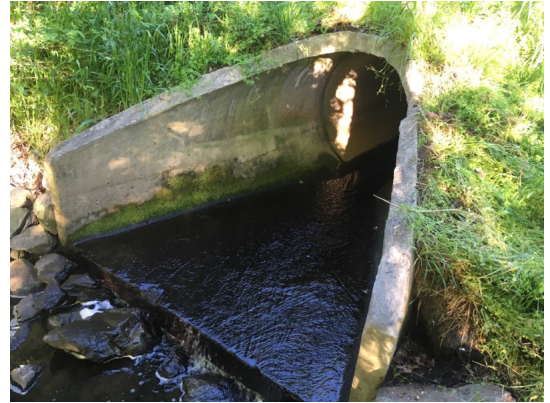
Outlet

Removed trash from the pond. Added Beneficial bacteria to the pond in order to help promote a healthy ecosystem. Hand pulled terrestrial vegetation growing up at both outlets to ensure that water flow was not impeded. Noted image 1 shows a secondary outlet. Noted image 2 shows erosion along one side of the primary outlet. Noted image 3 shows exposed soil along the pond slope. Noted image 4 shows exposed soil just before the creek inlet. Noted image 5 shows an area of erosion at the creek inlet. Noted image 6 shows an area of the shoreline that is holding water. Noted Image 1

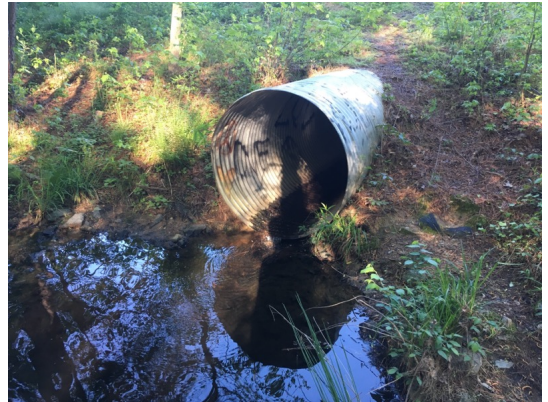
Outlet

Trash removed from the pond. Added beneficial bacteria in order to help promote a healthy ecosystem. Hand pulled nuisance woody vegetation along the shoreline and around the outlet. Observed a large amount of pollen on the surface of the pond. Cleaned the aeration filter. Noted image 1 shows a disturbed area along the pond slope closest to the road. Noted images 2, 3 and 4 show areas of bare soil and erosion on the shoreline of the pond. Noted image 5 shows the aeration box. Aeration system was running normally.

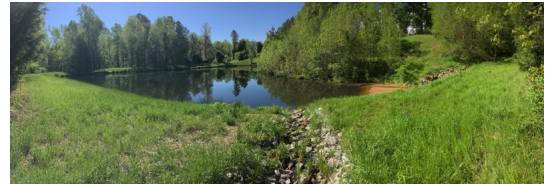
Pond Name	WP 3
Access Address	400 Market St, Chaple Hill, NC
Service Date	04/22/2019
Trash Pickup	SC= Service Completed
Treat Invasives	NN= Service Not Needed
Inlet service	SC= Service Completed
Outlet Service	NN= Service Not Needed
Unclog Drain	NN= Service Not Needed
Clean Riser/Trash rack	NN= Service Not Needed
Add Dye?	SC= Service Completed
Fountain/Aerator Condition	NN= Service Not Needed
Mow/Weed eat	WN= Work Needed
Overview of the pond

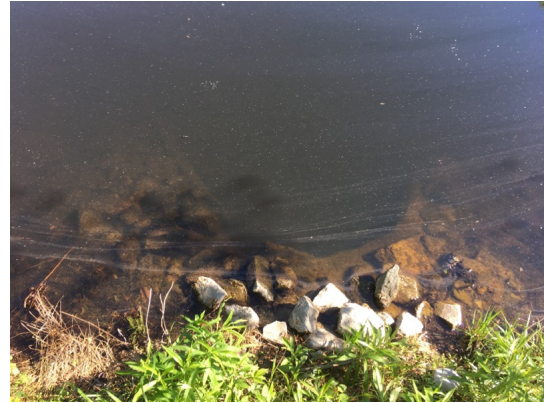
Inlet

Trash was removed from the pond. Treated terrestrial vegetation growing up in the rip-rap around the inlets. Added beneficial bacteria to the pond in order to help promote a healthy ecosystem. Noted image 1 shows a secondary inlet. Noted image 2 shows the creek inlet with sedimentation, exposed matting, and displaced rip-rap. Noted image 3 shows an area of bare soil and erosion in the head section of the pond. Noted image 4 shows a fallen tree on the backside of the dam near the outlet.

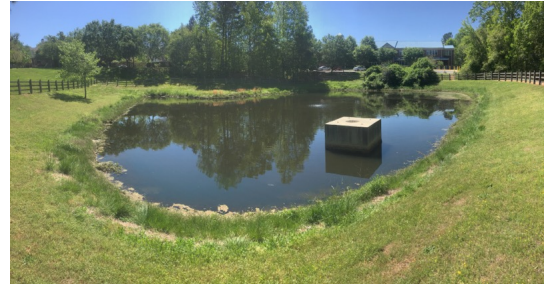
Fountain/Aerator Condition
Mow/Weed eat
Overview of the pond
